# Sealing of roof penetrations during building construction

Scott. A. Lowe

Lowe SA. Sealing of roof penetrations during building construction. *Building Engineering*. 2024; 2(2): 1381.  
<https://doi.org/10.59400/be.v2i2.1381>

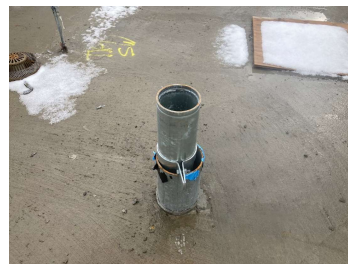
**Figure 1** shows a vent pipe sitting within the sleeve that penetrated the roof. The tape remnants indicate that the sleeve was initially sealed, but whoever positioned the vent did not bother to reseal around the pipe perimeter. **Figure 2** shows a soil stack vent where again the temporary seal on the sleeve was removed but not replaced when the pipe was centered. This pipe was left like this for weeks. **Figure 3** shows four small penetrations, maybe for electrical cabling, that were never sealed.

**Figure 1.** Vent pipe positioned in a roof sleeve. The pipe is not sealed nor is the gap between the sleeve and the pipe.

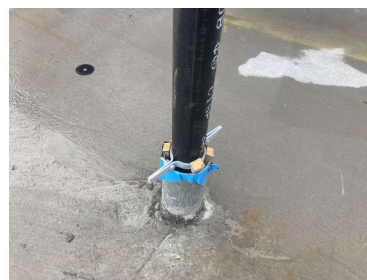
**Figure 2.** Temporary sleeve seal was breached by the pipe and not resealed.

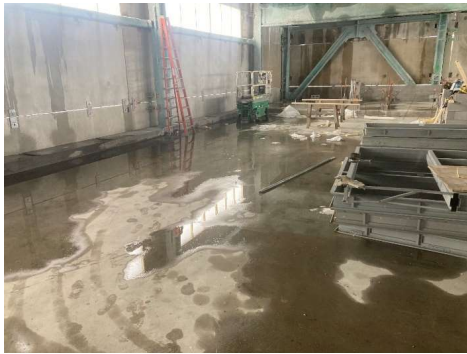
**Figure 7a** shows an auditorium floor that is recessed into the floor slab. As it began to rain, water immediately started to enter the auditorium area. **Figure 7b** also shows the auditorium an hour later, full of standing water. Notice how workers had to move bags of mortar off the floor and place them on some steel masonry reinforcement to keep them from being ruined.

**Figure 7.** (a) As it started raining water immediately began to enter this sunken auditorium area; (b) An hour later the floor had standing water.

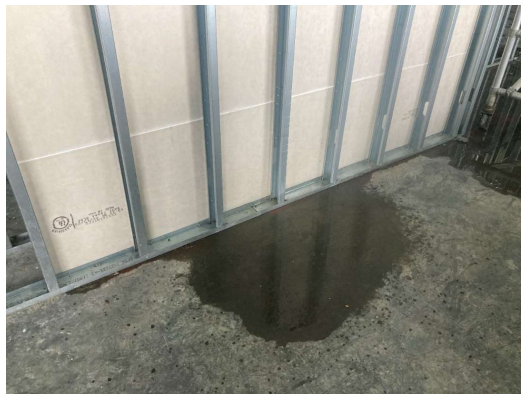
**Figure 8.** This was on the 1st floor of a six-story building. This drywall ultimately had to be replaced.

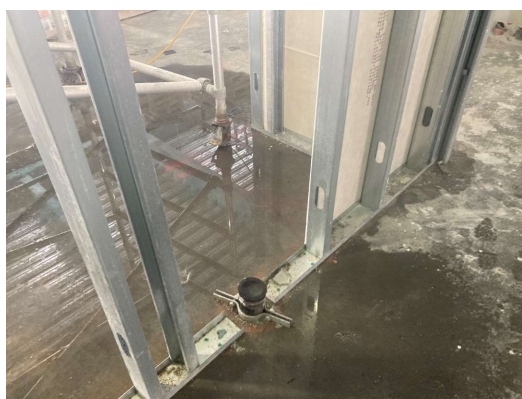
**Figure 9.** Water starting to spread to an area where drywall had just been installed—this also had to be replaced.

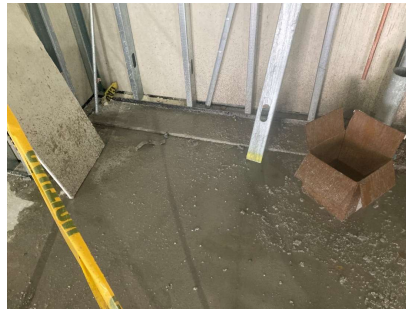
**Figure 10.** This was the day after the rain. The floors remained wet for another two days. Notice the caution tape and the wet drywall.

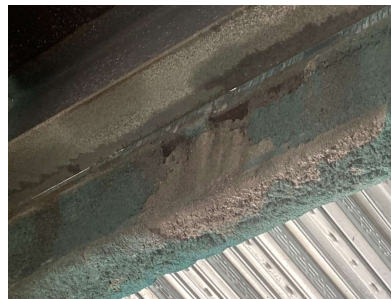
In steel-frame buildings, spray-on fireproofing is commonly used. This fireproofing does not interact well with water and easily sloughs off when exposed to almost any water. **Figures 11–14** show examples of this.

**Figure 11.** This fireproofing on the beam had already been patched (the light areas). It is in the process of sloughing off again as water leaks onto it – notice the exposed steel.

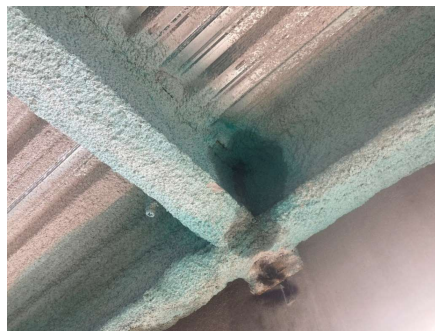
**Figure 12.** Water penetrating the fireproofing as it started to rain.

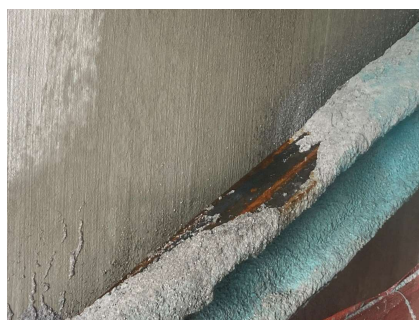
**Figure 13.** Fireproofing washed away as water ran down the inside of a precast wall panel.

**Figure 17** shows a building with precast concrete wall panels as the façade. There is always a gap between the end of the floor slab and the wall panels. The figure shows water flowing to the edge of the slab and falling down between the gap to the floors below. This caused the damage to the sprayed-on fireproofing shown previously in **Figure 13**.

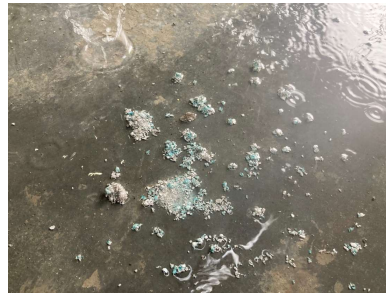
**Figure 14.** This is fireproofing on the floor that had sloughed off a column.

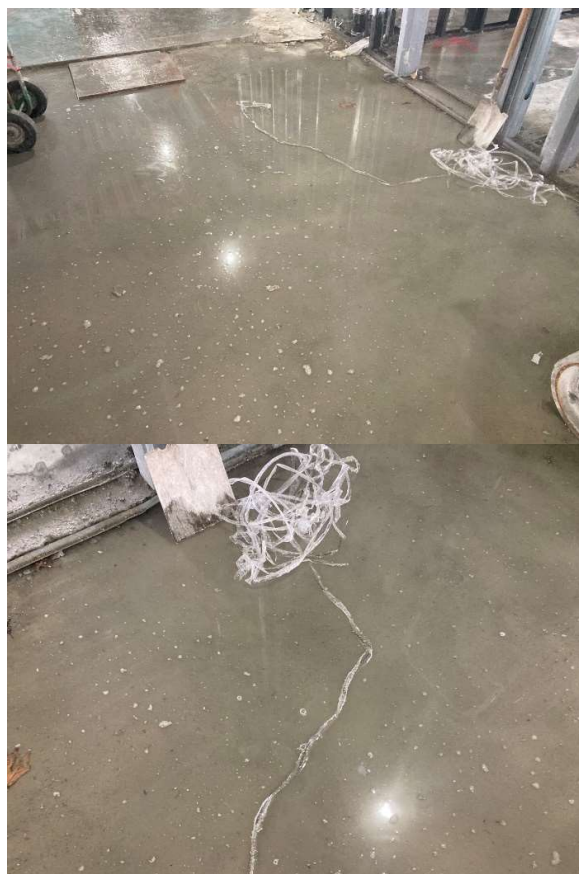
**Figure 15.** Poor working conditions due to wet floors. This is several floors below roof level.

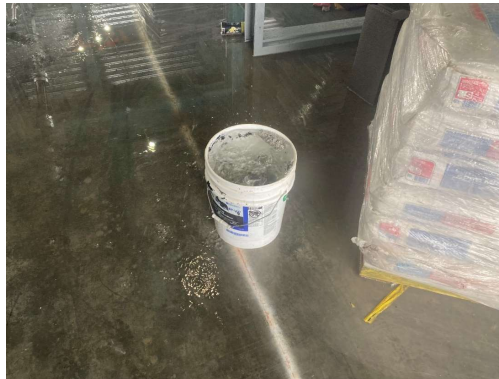
**Figure 16.** This bucket was placed under a leak. Eventually it filled up and overflowed.

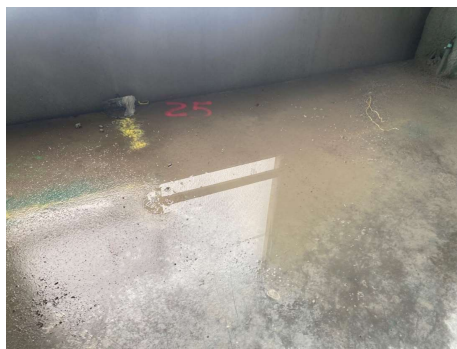
**Figure 17.** This building has precast concrete wall panels. Water is running off the floor slab and falling down between the gap to lower floors.
