Thermal imaging-based fault detection and energy efficiency analysis in a 1.6 MW photovoltaic system in Bağyurdu OIZ, Türkiye

Cihan Yalçın

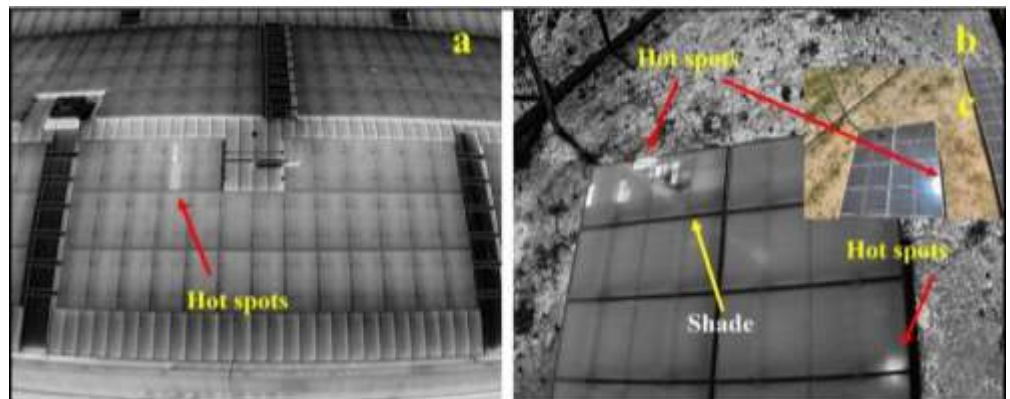
Figure 1 clearly shows that elevated temperatures in some regions of the panels distinguished hot spots. Populations of this type have the potential to induce elevated temperatures in panels, thereby reducing their lifespan and resulting in significant reductions in their power-generating capacity [13]. Research conducted by Silvestre et al. [14] indicated that excessive heat accumulation in PV modules might lead to long-term fire hazards.

Figure 1. Thermal anomalies were identified in the panels at the Bağyurdu OIZ.

Thermal analysis indicates that 15% of the total modules of Bağyurdu OSB are defective, resulting in energy losses, as illustrated in the image.

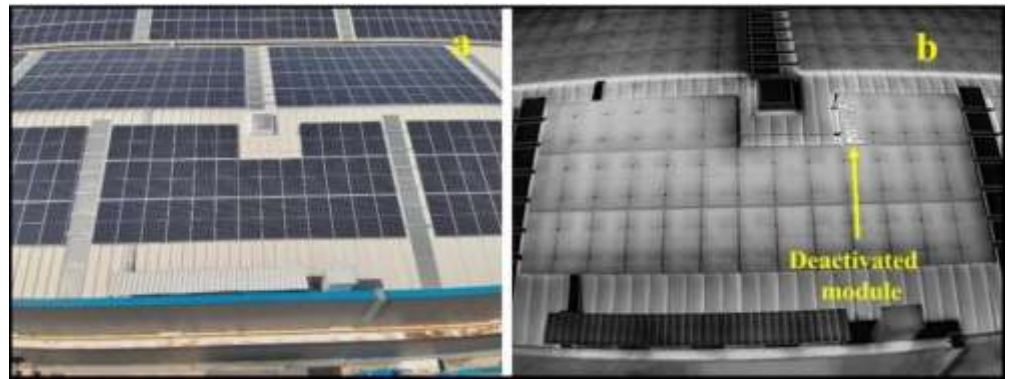
Figure 2 shows the thermal picture of a malfunctioning module. Identifying and rectifying such defects is essential to minimize energy losses [10].

Figure 2. Thermal visualization of the deactivation modules at the Bağyurdu OIZ.

Figure 2 illustrates the identification of deactivated photovoltaic modules in the thermal pictures. The study of thermal images indicated that 1.6% of the total modules were deactivated, leading to a substantial decrease in yearly energy production capacity. The effect of the malfunction of these modules on the system's overall performance was assessed using the below formula:

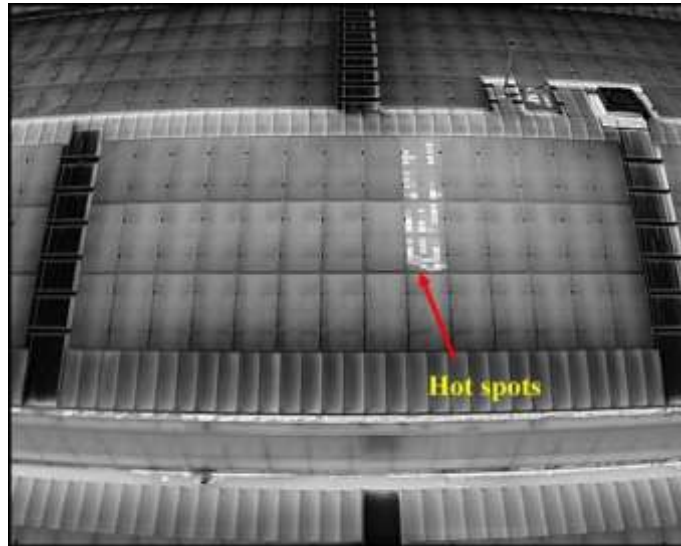
Thermal anomalies were identified at the junctions between the panels and the inputs of the inverter devices. Specifically, elevated temperatures were detected at some connection locations due to defective soldering or loose connections. This leads to a rise in electrical resistance and thus generates energy losses. During the inspections conducted at Bağyurdu OIZ, the issues primarily focused on the inverter inputs and panel connection facilities. A significant determinant of the system's overall efficiency is defective connections [11].

Figure 3 illustrates the phenomenon of component overheating caused by defective connections. Interconnection failures of this type may adversely affect the safety and efficiency of PV systems [2].

Figure 3. Photothermogram showing components experiencing excessive heat caused by defective connections.

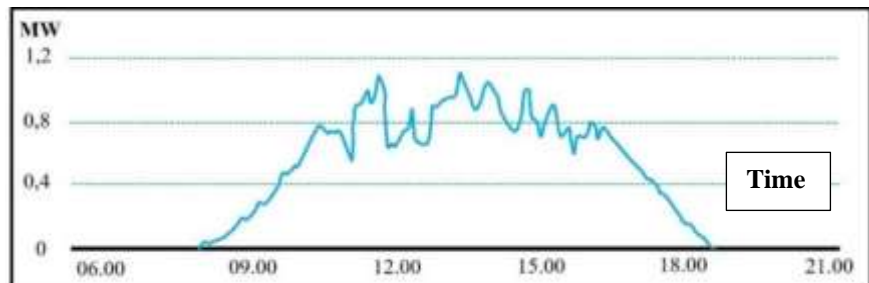
Figure 4 shows the generated data acquired on a day with partial cloud cover. Shadowing has a substantial impact on PV systems' efficiency, so optimization techniques must be devised to mitigate these impacts [7].

Figure 4. Observations of energy generation variations caused by shade on a partially overcast day at Bağyurdu OIZ SPP.
