# Resistance of HVOF-Sprayed Cr<sub>3</sub>C<sub>2</sub>-25NiCr and WC-10CO-4Cr coatings to cavitation and erosion by mud jetting

ABSTRACT: This study investigates chromium carbide-based coating material's cavitation and erosion resistance with 25% nickel-chromium. (Cr<sub>3</sub>C<sub>2</sub>-25NiCr) and Tungsten carbide coating with 10% cobalt and 4% chromium (WC-10CO-4Cr) coatings deposited by high-velocity oxygen fuel (HVOF) thermal spraying. The coatings were characterized by microstructure, porosity, hardness, and fracture toughness. Cavitation tests were performed in distilled water and water-sand mixtures to assess the synergistic effect of erosion and cavitation. Erosion tests were conducted using a mud jet at different impact angles (30°, 60°, 90°). The Cr<sub>3</sub>C<sub>2</sub>-25NiCr coating exhibited higher cavitation resistance due to its higher fracture toughness and lower porosity. However, the WC-10CO-4Cr coating showed superior erosion resistance, attributed to its finer and more homogeneously distributed carbides. The dominant wear mechanisms were micro grooving, carbide detachment, and cracking. The impact angle significantly influenced the erosion rates, wit

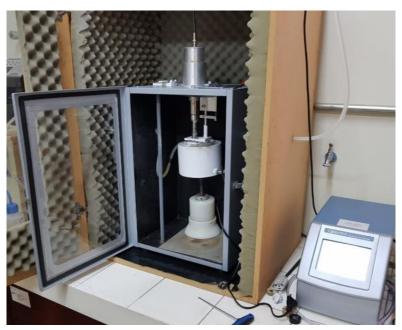
Figure 5. Cavitation test equipment.

The cavitation test seeks to evaluate the resistance of materials when subjected to the cavitation phenomenon. The most direct way to obtain such resistance It is by studying the mass loss of the material. The cavitation tests were performed using equipment from the Qsonica Q700 ultrasonic machine located in the Metallofigureic Preparation Laboratory of UTFPR-PG. The image of the equipment is shown in **Figure 5**.
