Implementation of the floor impact noise monitoring system to the existing apartment buildings

Abstract: Floor impact noise has been the prior social issue nowadays since most people are living in apartment buildings in Korea. Even though much research has been undertaken to reduce the floor impact noises architecturally and regulations were strengthened, the disputes concerning this matter have been increased. The present study is the first trial to solve this problem using ICT technologies called floor impact noise monitoring system. This system is to be operated all day long in the buildings monitoring real time all the noises for the reduction of the occurrence of floor impact noises. The system consists of sound and vibration sensors, a wireless communication gateway and the main server with analyzing software. In order to enhance the accuracy and durability of the system, the suitability tests for sensors were executed in an anechoic chamber using many current sound and vibration sensors. Also, the system was tested at the authority laboratory for the verification. The operating algorithm was first made satisfying with the current regulations in Korea, but it was modified se

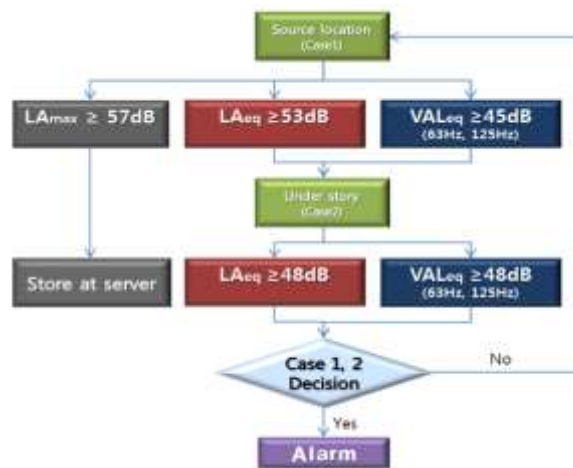
The basic algorithm of the system has been modified several times with feedback procedures from the many tests. The major difference between the basic and modified algorithm is the application of reference limits to both sound source and receiving room respectively. Also, VALeq was used for modified algorithm instead of VAL'max. In modified algorithm, measured noise and vibration levels exceed both limits of source and receiving rooms, alarm is delivered to the source room location [5]. **Figures 2 and 3** show the basic and modified algorithm of the system.

Figure 3. Modified algorithm of the system.

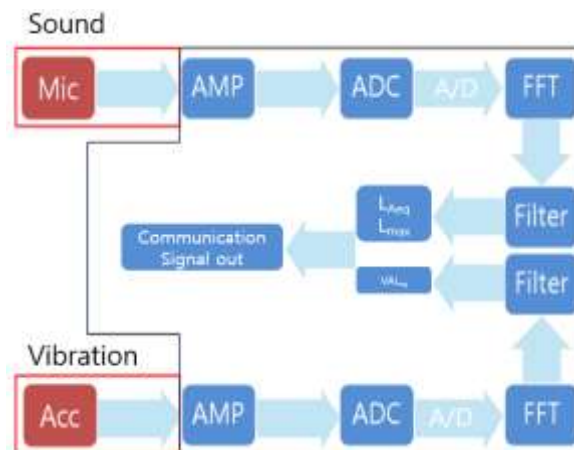
Figure 4 shows the sound and vibration signal path from the sensors to communication device. **Figure 5** shows the system configuration of a building with an example of the system outputs including date, time, measured sound and vibration level (LAeq, LAmax, VALeq) and the location.

Figure 4. Sound and vibration signal manipulation chart.

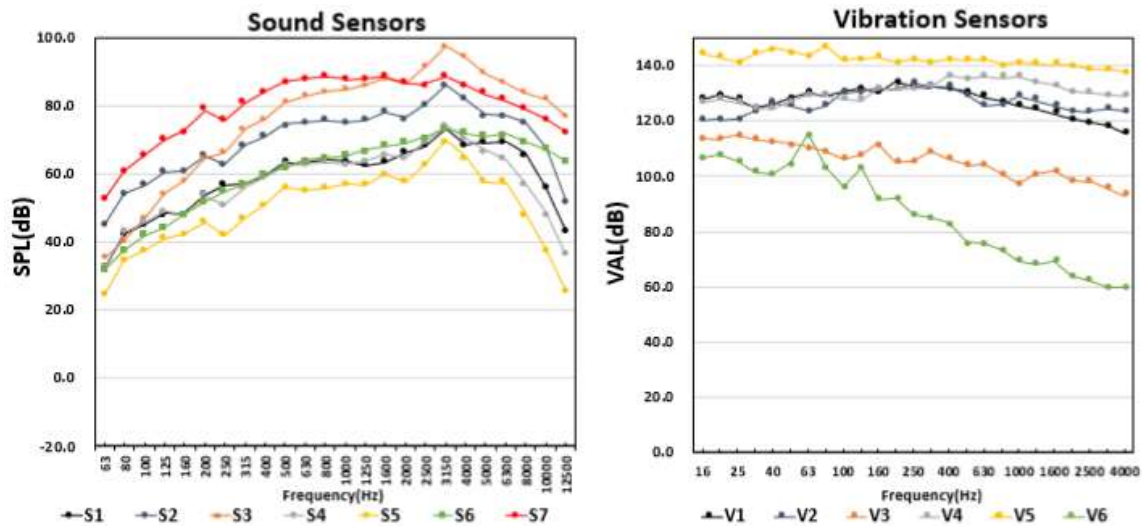
As shown in **Figure 6** it was found that dynamic type microphones (S4) show the most similar frequency response sound level characterization in comparison with the reference condenser microphone especially in the air-borne sound frequency range from 250 Hz to 2K Hz. Regarding vibration sensor, it was found that spring-type (V4) vibration meter shows the most similar characteristics of vibration acceleration level (VAL) at 63 Hz, most critical structure-borne sound frequency. Thus, the results drawn from the round-robin tests were used for floor impact noise monitoring systems with the benefit of both economy and performance [6].

Figure 6. Measured sound level of sound and vibration sensors tested.

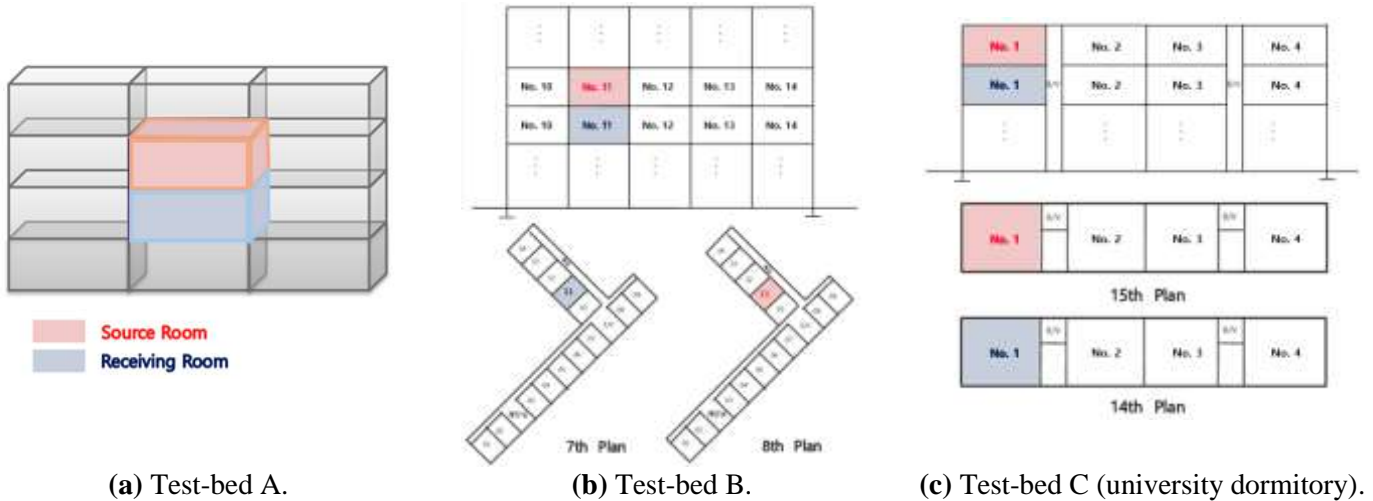
O apartments were built before 2004 with only 150 mm thickness of concrete slab while test-bed C is a university dormitory built in 2012 with 180 mm thickness of concrete slab. Plan and section of each test-bed apartments are displayed in **Figure 8** with the location of source and receiving rooms.

Figure 8. Plan & section of each test-bed apartments.

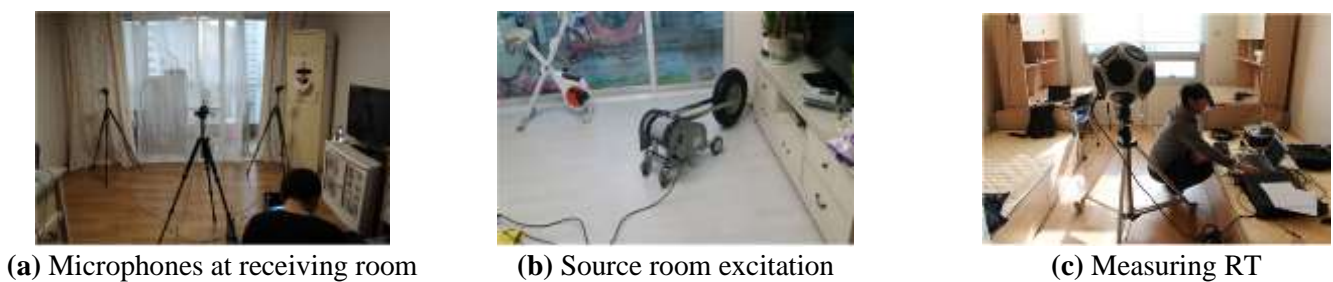
Standard floor impact sound sources were used to measure both lightweight and heavy-weight floor impact noises including tapping and bang machine respectively. Background noise levels were measured, and the reverberation time was measured for the calculation of average sound absorption in rooms (refer to **Figure 9**). Floor impact noise levels were measured at the frequency range from 31.5 Hz to 4K Hz with 1/3 Octave bands. The measured level of each test-bed is listed in **Table 8**. As shown in **Table 8**, the floor impact noise insulation performance is getting better in accordance with the year of completion. It is revealed that both light and heavy-weight floor impact noise insulations of test-bed A are out of grades. It may be because of the aging effect of building and thin concrete slabs.

Figure 9. Floor impact noise measurements.

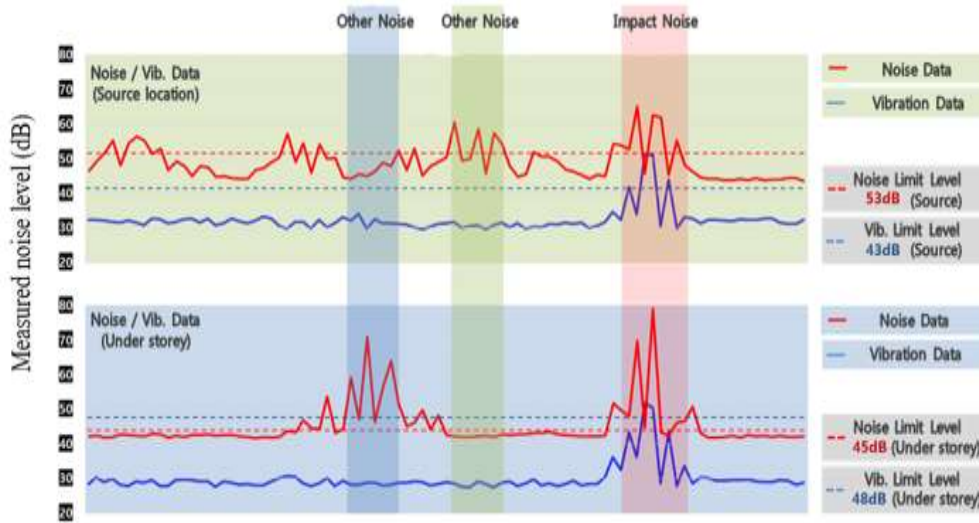
Figure 11. Example of the stored noise & vibration data including both impact noises and other general interior noises.

Figure 11 shows an example of the stored noise & vibration data including both floor impact and other noises in a vertically connected unit. There are two conditions to determine the occurrence of floor impact noises, only when noise and vibration levels exceed the reference level in the two units at the same time, the system decide that the floor impact noise occurs and recorded the data in the computer sever. The limit level of noise in source room is 53 dB and 43 dB for vibration level while the limit level of noise in receiving room is 45 dB and 48 dB for vibration. The vibration level of the under story is larger than the vibration level of upper story since the vibration meter is installed on the ceiling of room at under story. When other noises have occurred, the noise and vibration level do not make peak contour at the same time as shown in **Figure 11**. Also, floor impact noise can be distinguished using frequency analysis. With the satisfaction of two conditions written above, sound peaks at the range from 63 Hz to 125 Hz are recognized as the floor impact noises.

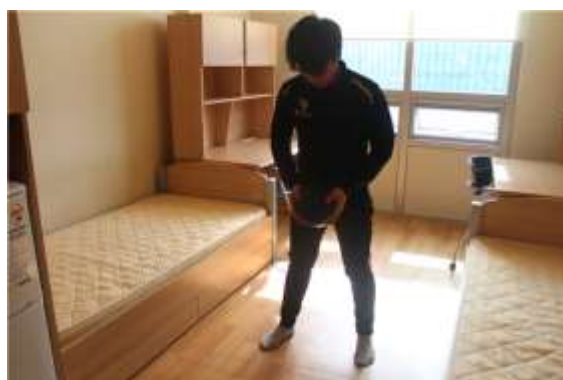
The 2nd Test was undertaken after modifying the source location tracing algorithm a few months later. At the 2nd test, 6 rooms were randomly selected by an impactor and the same procedures were executed as precisely as the 1st test. **Figure 12** shows the source room excitation using a rubber ball by the impactor. Totally 8 trials were done in 6 rooms and all the trials were in tune with noise source and alarmed location. This means 100% of, accuracy of correct localization. **Table 10** shows the results of the 2nd test for system verification.

Figure 12. Floor impact noise measurement using rubber ball.
