# Vibro-dynamic testing of a 6-story building and reliability assessment taking into account deformation nonlinearity

**Abstract:** The paper presents the results of vibro-dynamic testing of a 6-story residential building constructed in an area with a seismic intensity of 10 points. The novelty of the study lies in the full-scale testing of a six-story monolithic building and the subsequent use of the test results to calculate reliability as the probability of failure-free performance. The results obtained make it possible to predict the behavior of the building under seismic action. Structurally, the investigated building is a spatial cross-wall system. The basement and above-ground floors are made of monolithic reinforced concrete structures. The dynamic loading is generated by an inertial vibration machine. Vibration measurements were carried out using a digital instrumentation and measurement system. It is shown that the building deforms nonlinearly. The stiffness of the “test object–foundation” system decreased by a factor of 2.14 compared with its initial stiffness, while the stiffness of the object’s “structural system” decreased by a factor of 1.37. The dissipative forces

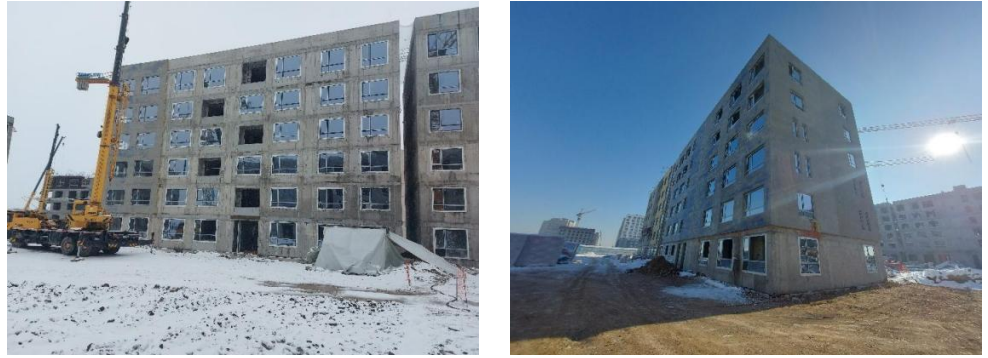
**Figure 1.** General views of the 6-story residential building of the Arena Park Standard 1 residential complex.

General views of the 6-story residential building of the Arena Park Standard 1 residential complex are presented in **Figure 1**.

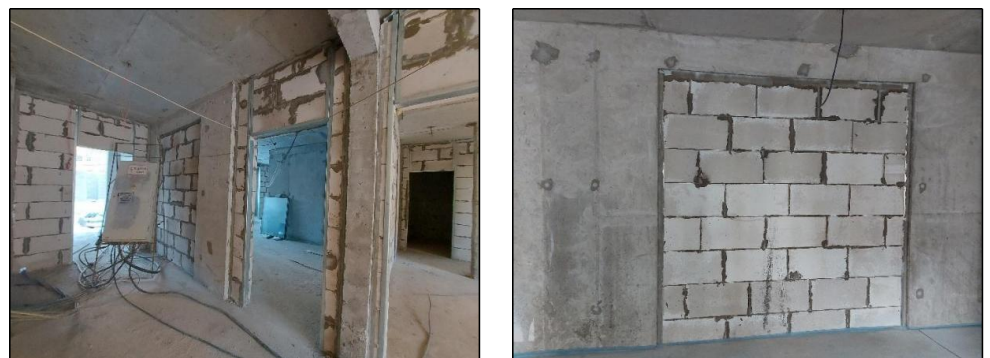
**Figure 4.** General design solutions for non-load-bearing structures.

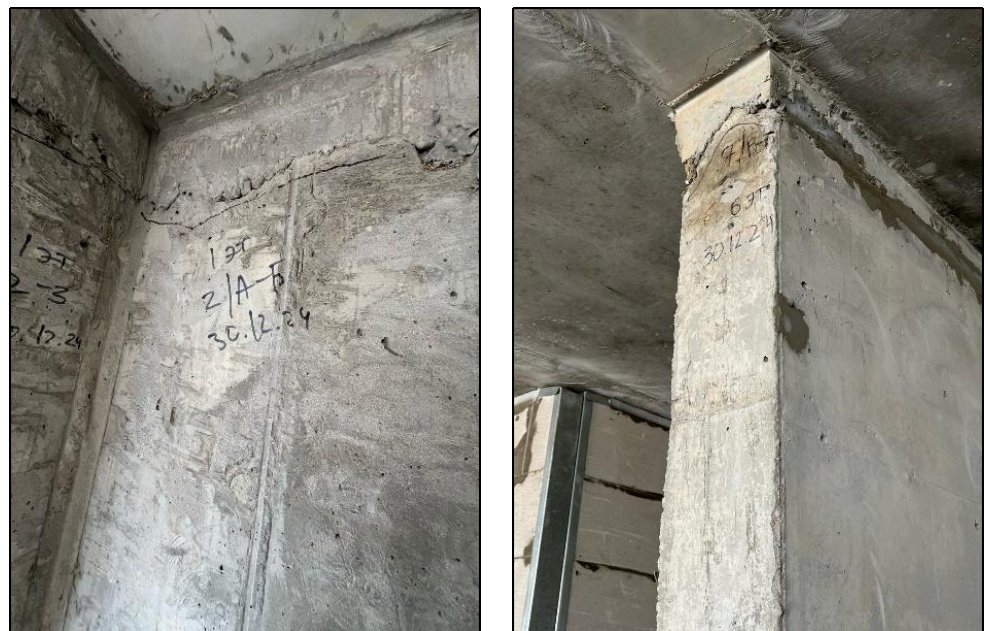
- Concrete overflows were detected at the junctions of vertical structures with the floor and roof slabs, see **Figure 6**;
- In the corners of window and door openings, in some places there are minor hairline cracks with an opening width of less than 0.05 mm, see **Figure 7**;
- Minor concrete spalling and process cracks were detected in the vertical wall structures, see **Figure 8**.

**Figure 6.** Concrete sag at the floor and roof level.

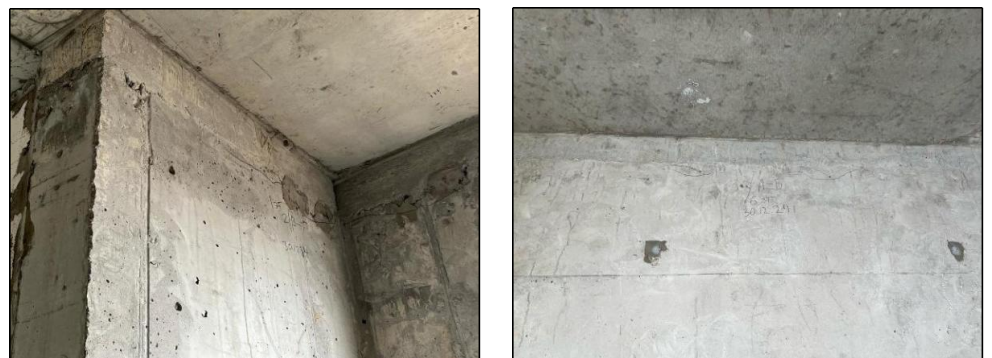
**Figure 8.** Concrete spalling at the floor and roof level, and process cracks in vertical structures.

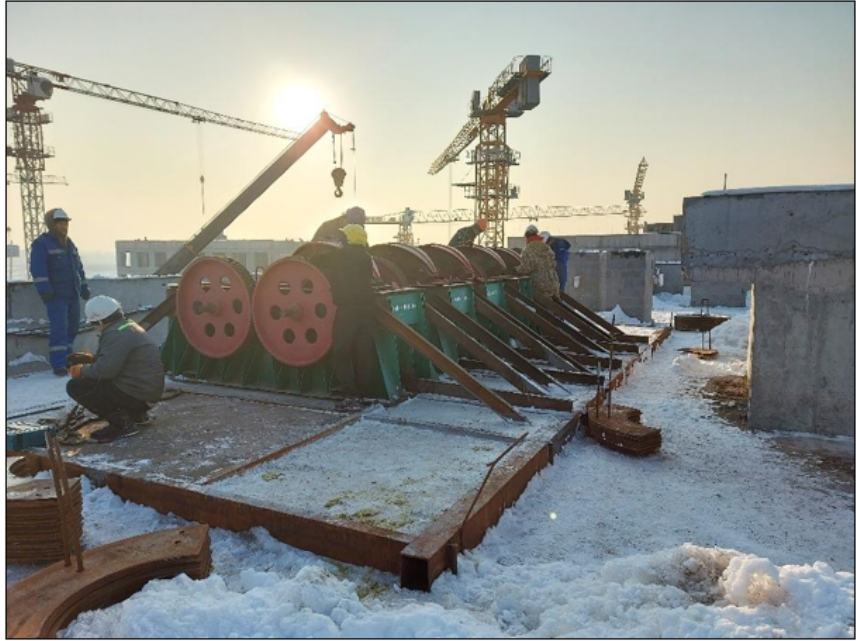
During testing, the motor and vibrators were rigidly attached to a horizontal steel frame located at the building's roof level. The steel frame was rigidly attached to this roof.

The layout of the vibration machine on the building's floor is shown in **Figure 9**. From **Figure 9**, it can be seen that the adopted layout of the vibration machine allowed for the excitation of building vibrations in the intended direction of one of its main orthogonal axes of inertia in the transverse direction of the building.

**Figure 9.** Inertia-type vibrating machine.

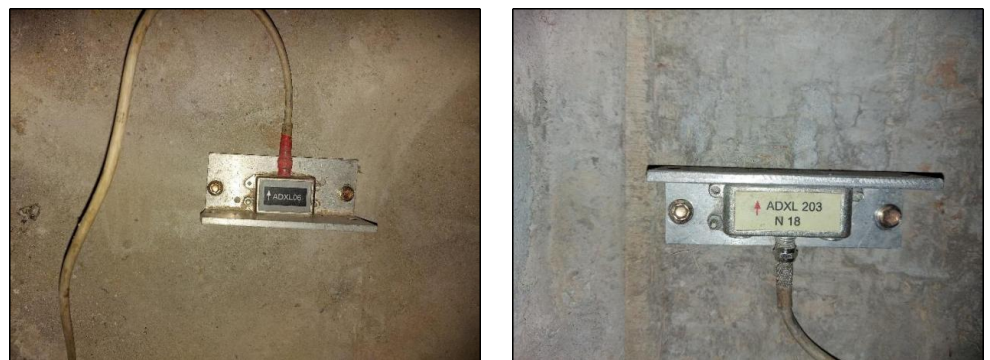
**Figure 11.** General views of sensors.

A total of 38 accelerometer sensors were used in the tests.

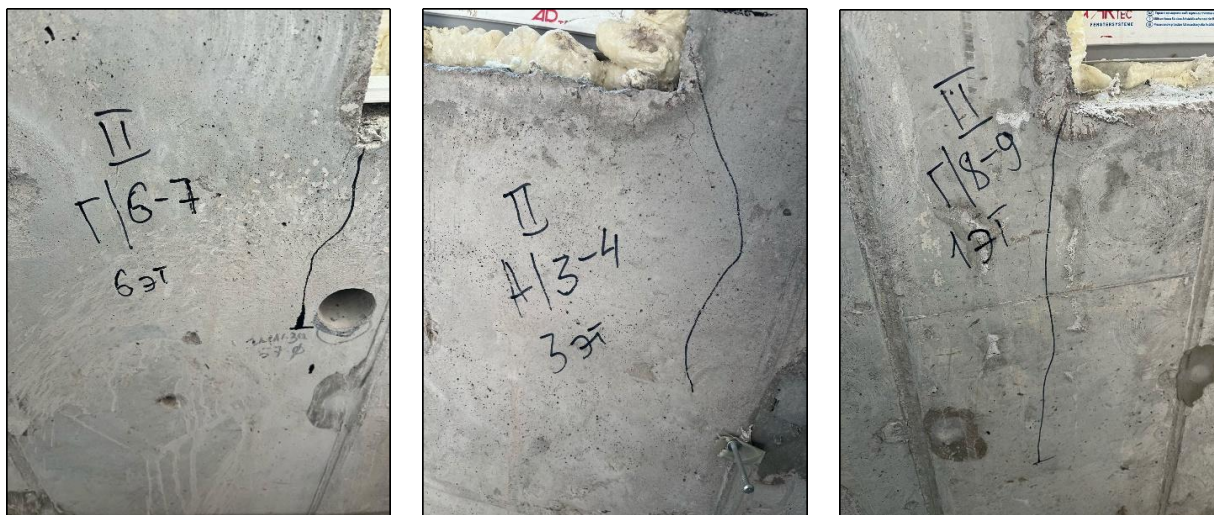
There was no significant damage to the supporting structures of the experimental object after all stages of vibration exposure. Only in individual load-bearing walls and lintels were hairline cracks of varying lengths observed, developing from the corners of window and door openings, and minor openings of existing cracks of a technological nature in the walls (see **Figure 14**).

**Figure 14.** Small hairline cracks developing from the corners of window openings after stage II.

- a) All cracks that have appeared and are present during all stages of testing must be cleaned and then grouted.
- b) All unevenness on the surface and at the corners of the concrete should be leveled with a cement-sand mortar of at least grade M200.

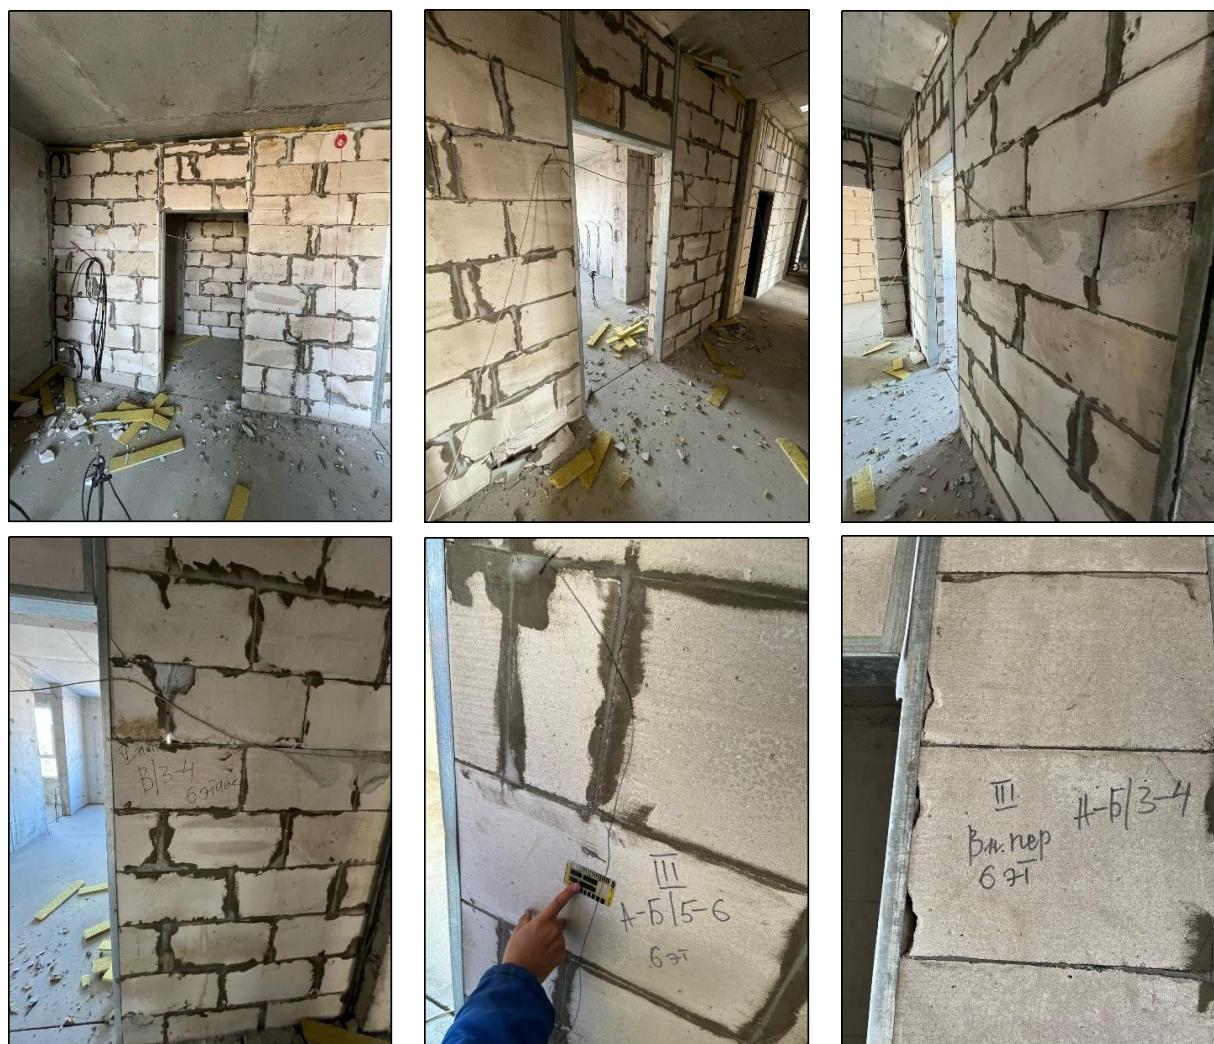
In separate non-load-bearing structures (partitions) and in places where they adjoin adjacent structures, the formation of cracks, partial crumbling of cement-sand mortar at the floor level, and partial damage to the stonework and chips (aerated concrete blocks) were visually noted (see **Figure 15**).

**Figure 15.** Damage to partitions at the junctions with the floor.

- c) Gaps that have formed where partitions meet load-bearing structures must be cleaned and then sealed.
- d) Damaged masonry of superstructures on the roof must be dismantled and subsequently restored.
