# Examination of surface contamination and impurities in tinplate samples, both passivated and non-passivated

**KEYWORDS:** tinplate surface; surface impurities; unwanted elements; passive

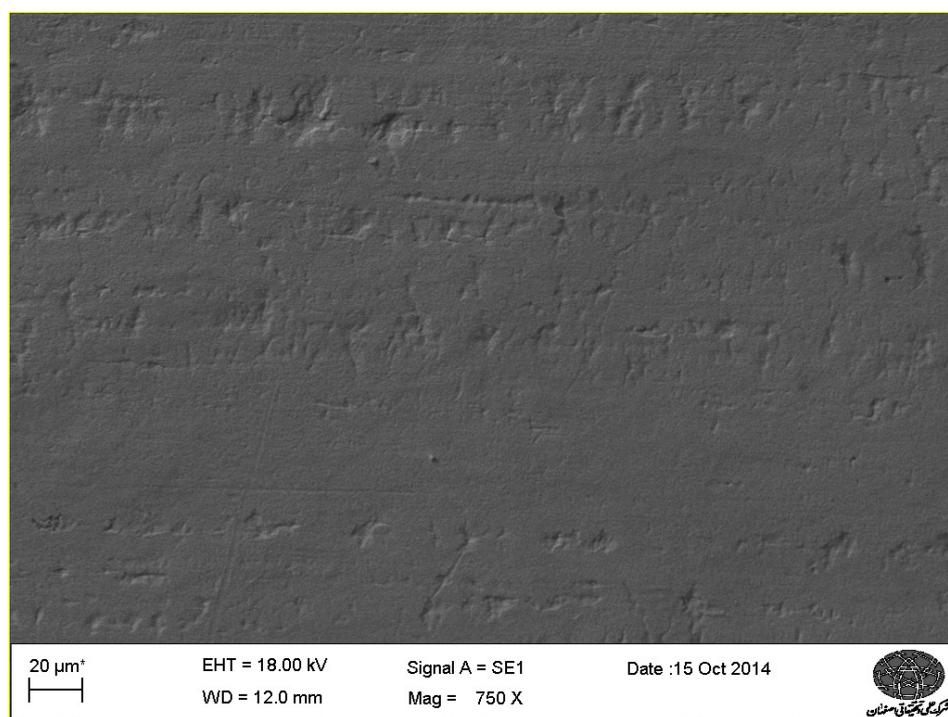
**Figure 1.** SEM of non-passivated sample.

The surface morphology and microstructure of both passivated and non-passivated samples were examined using SEM and EDS analysis. The SEM and EDS results of the non-passivated sample are illustrated in **Figure 1** and **Figure 2**. The surface exhibits burrs, notches, and impurities. EDS analysis revealed the presence of O, Sn, and Fe, with Fe accounting for around 13 atomic%. As a result of the presence of impurities on the surface, further investigation was necessary. SEM analysis showed that impurities A and B were present on the surface of the non-passivated sample, as shown in **Figure 3** and **Figure 4**.

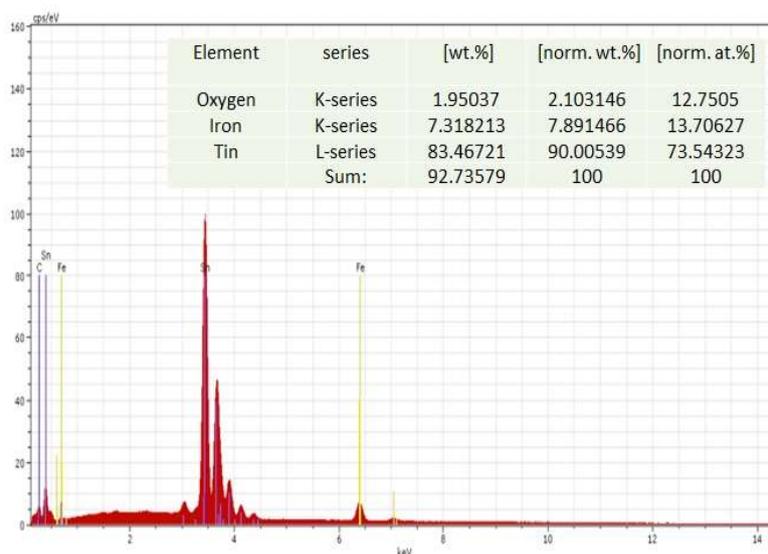
Figure 2. EDS result of non-passivated sample.

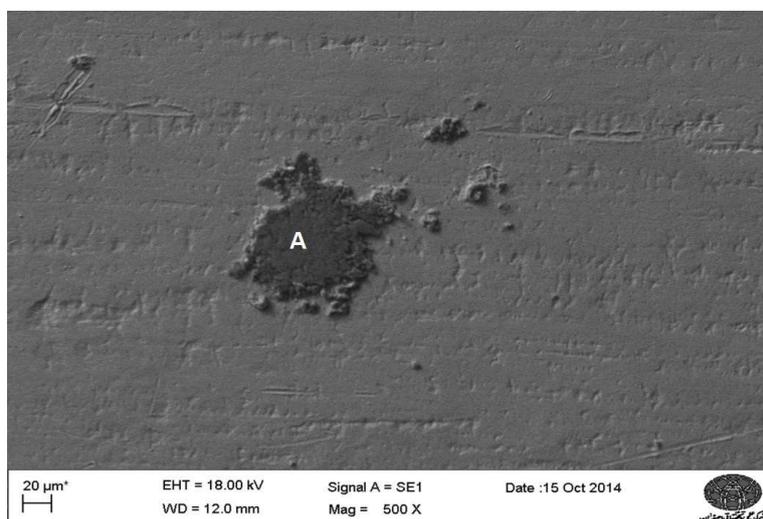
Figure 3. SEM of impurity (A) on the non-passivated sample.

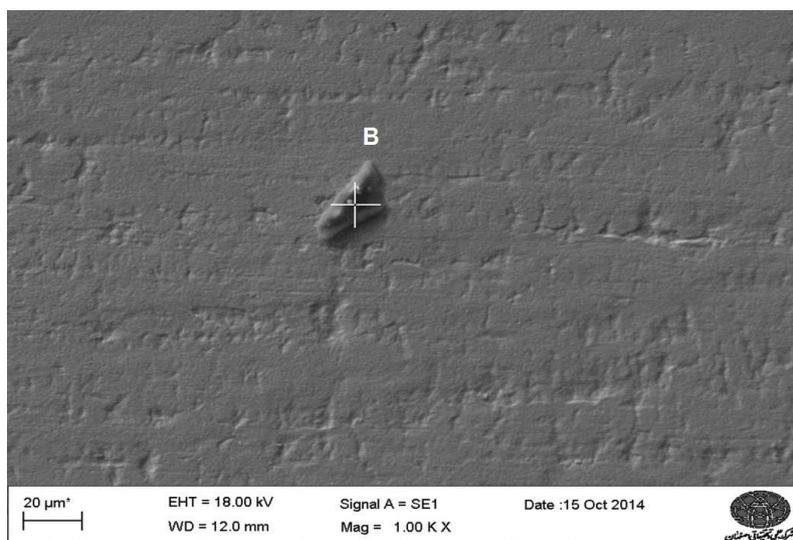
Figure 4. SEM of impurity (B) on the non-passivated sample.

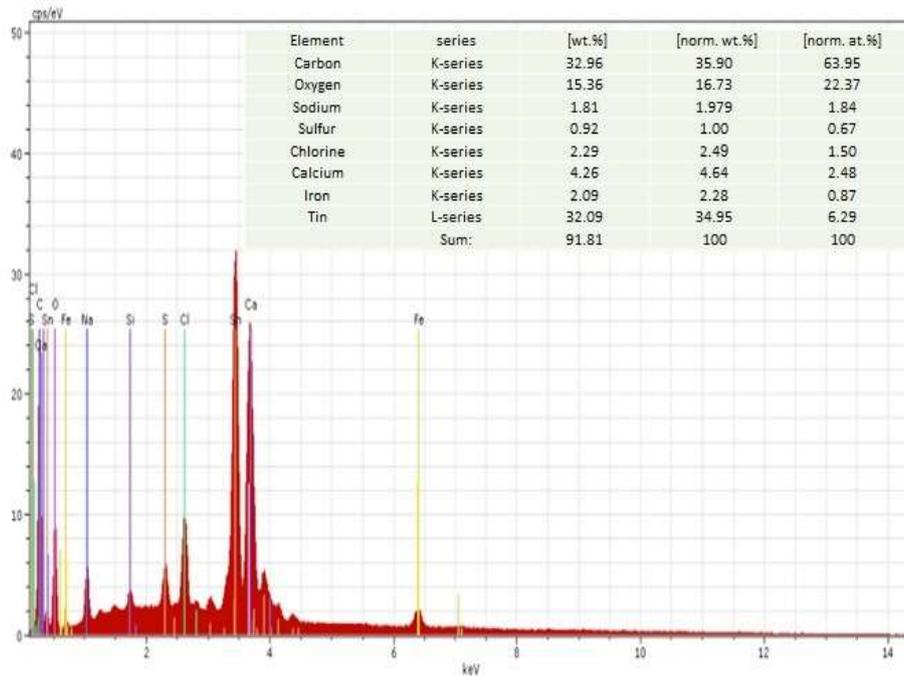
**Figure 5.** EDS result of impurity (A) on the non-passivated sample.

The EDS analysis of these impurities (A and B) is presented in **Figure 5** and **Figure 6**. Unwanted elements, including Cl, O, Fe, S, C, Mg, Al, Si, Ca, and Na, were detected. The turbulence of the coating electrolyte may cause impurities to transfer to the strip surface. These impurities can then move to adjacent cells through the strip and contaminate their solutions as well.

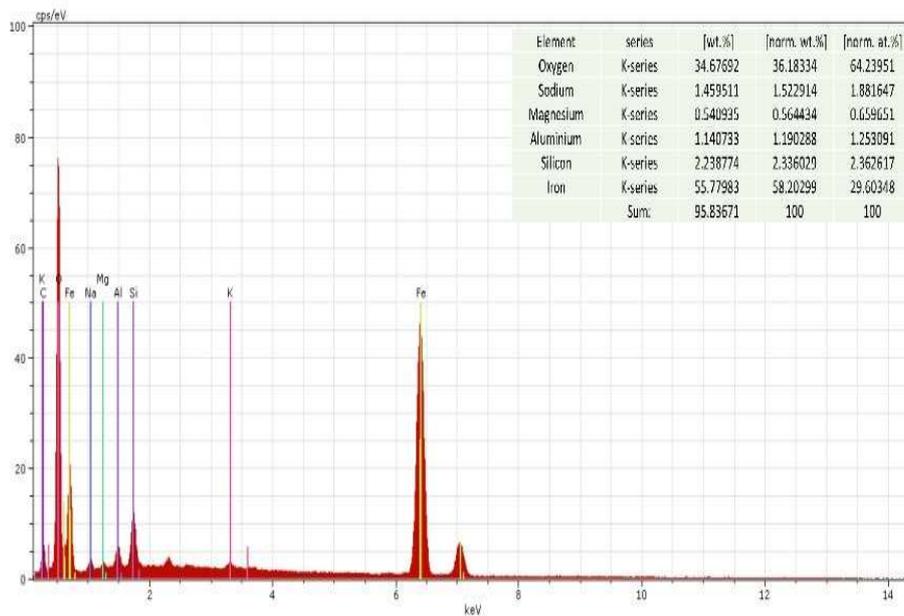
**Figure 6.** EDS result of impurity (B) on the non-passivated sample.

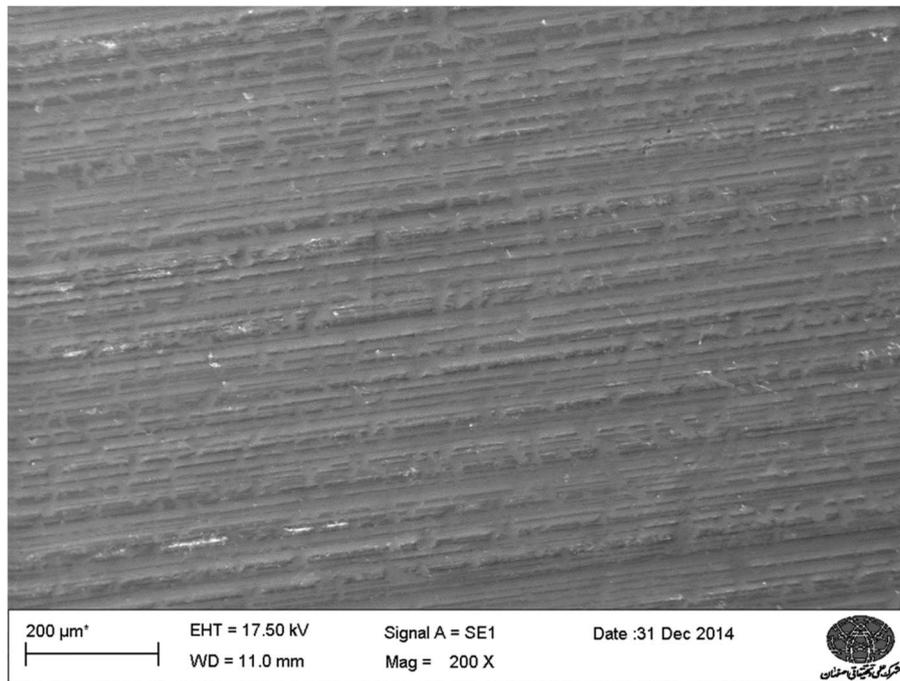
Figure 7. SEM of passivated sample.

The SEM result of the passivated sample is displayed in **Figure 7**. Dark and light parallel areas, indicating the rolling direction, were observed in **Figure 8**. The EDS analysis of the light and dark areas is presented in **Figure 9** and **Figure 10**, which confirmed that the dark areas were enriched in Fe with a

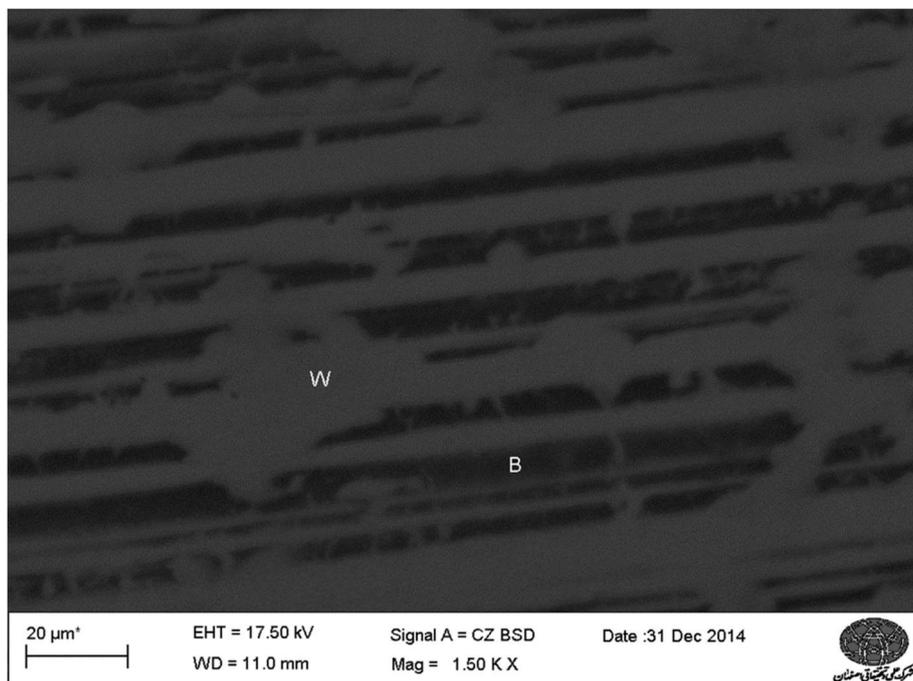
Figure 8. SEM of passivated sample on dark & light areas.

The oxygen content in the bright area depicted in **Figure 8** is relatively low. The relatively low oxygen content in the passive area of the tin plate can be attributed to the formation of a protective layer or film that impedes further oxidation. Tin plates often develop a passive layer. This layer acts as a barrier, reducing direct contact between the underlying metal and the surrounding environment. Consequently, the availability of oxygen for further oxidation reactions on the surface decreases, resulting in a relatively low oxygen content in the passive area of the tin plate. This protective layer helps maintain the metal's integrity while limiting the extent of oxygen interaction, thereby keeping the oxygen content comparatively low in the passive region.

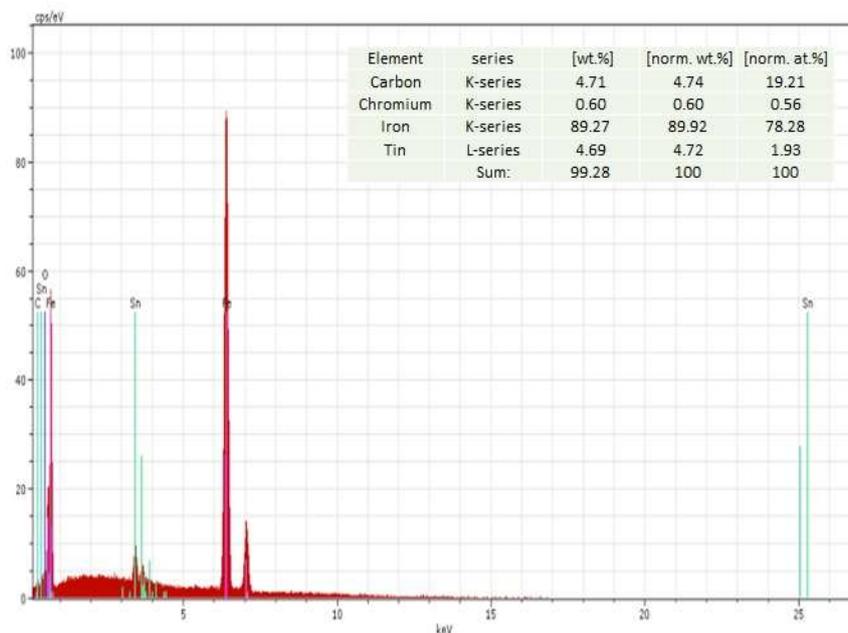
Figure 9. EDS of B point (dark area) on passivated sample.

high concentration of C as an unwanted element. Cr was also observed in the dark areas. The light areas were rich in Sn, with a high concentration of C as an unwanted element, similar to the dark areas.

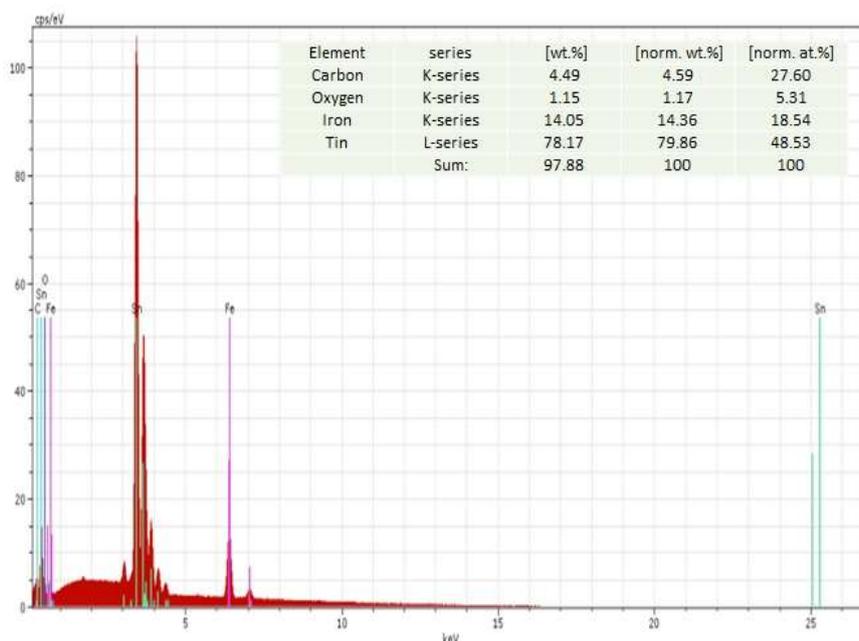
Figure 10. EDS of W point (light area) on passivated sample.

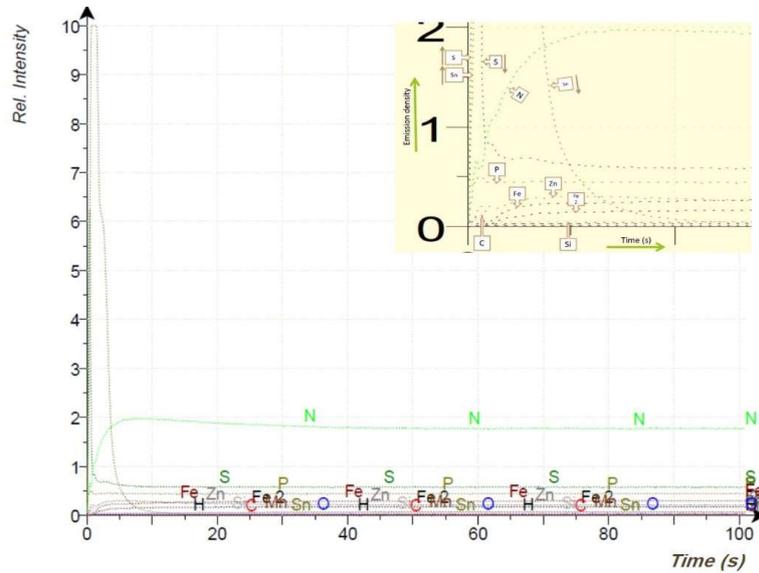
**Figure 11.** GDOES result of non-passivated sample.

sample. The results showed that for the non-passivated surface, S was detected in the first moment, and then Sn was exposed to large amounts as specified in **Figure 11**. N, P, Zn, C, and Fe were also present. In this experiment, Si and Mn were not observed. After the preliminary detection of C, it was reduced to zero by test time. In terms of priority element detection by the device, S, N, Sn, P, Zn, C, and Fe were detected on the surface in the first moments of the test. As mentioned above, a large amount of S, N, and Sn was available on the surface.

Applying a coefficient of 50 times on the display of S, P, and N, S and before Sn are revealed as the first element in the non-passivated sample in GDOES. This suggests that S exists on the surface of the entry strip to the passivation cell, which can prevent a correct cathodic dichromate passivation process and also dissolve in the passivating solution, infecting it as an unwanted element. S is also observable in the ICP results of the plating electrolyte as well as the passivation solution. According to GDOES analysis, nitrogen and phosphorus were found to be located beneath the strip surface, following the detection of sulfur and tin. The increase in nitrogen emissions and decrease in tin emissions suggest that the nitrogen source may be either the tin plating or surface melting sections. Phosphorus, on the other hand, is believed to have been transferred from the cleaning section to the plating section during strip processing. Si was observed in the passivation solution ICP results (**Table 2**) and contributed to an early peak in the GDOES results of the passivated sample (**Figure 12**). Cr, as well as Sn, S, N, and P, were detected in the passivated sample results. The presence of Sn in the GDOES results was attributed to its presence in the passivation solution rather than the coating process. The sequence of element detection in the passivated sample revealed the interference of C and Zn in the passivation process, with C and Zn being detected after Cr. The significant presence of C in both the EDS and GDOES results of the passivated sample indicates that the strip carries a certain amount of plating electrolyte as it passes through the cells in the line.

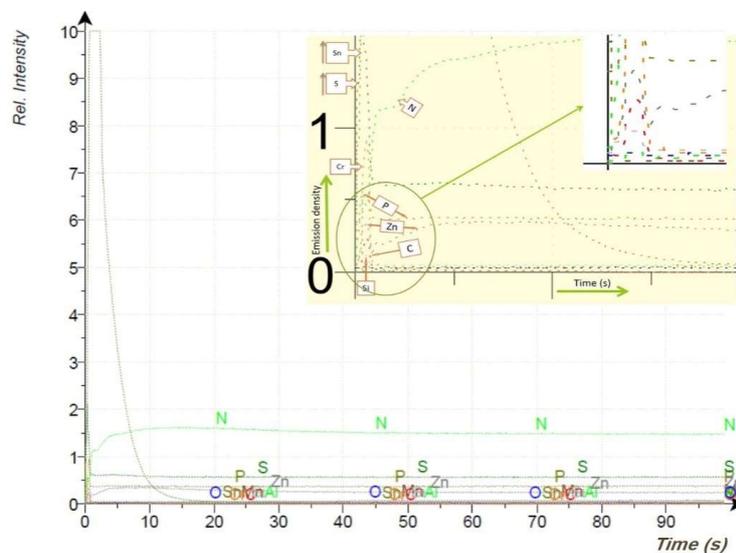
**Figure 12.** GDOES result of passivated sample.

The GDOES graph in **Figure 12** reveals the chemical composition of the pollution on the passivated surface. Upon closer inspection of the graph, high peak intensities of C, S, Zn, and Si were observed in the first moments along with abundant Sn, which declined over time. Cr also had a strong peak that completely dropped with time. Based on the peaks of N, P, Zn, Fe, and Si in the early moments, of the test, it can be concluded that in very thin profiles of the surface, Sn, S, Cr, N, P, Zn, Fe, Mn, C, and Si exist, representing the chemical composition of the pollution on the surface. In terms of priority element detection, Sn, S, N, P, Cr, Zn, Fe, Mn, and Si were the most apparent.
